**Washington State Ferry Terminal
Structural Inspection**
By the Bridge Preservation Office

Kingston Ferry Terminal

Location	Bridge No.	Type	Inspection Date	Report Received
Slip 2	104/10FT	Routine & FC	9/10/2019	11/18/2019

Br. Name KINGSTON (MAIN - SLIP 2)

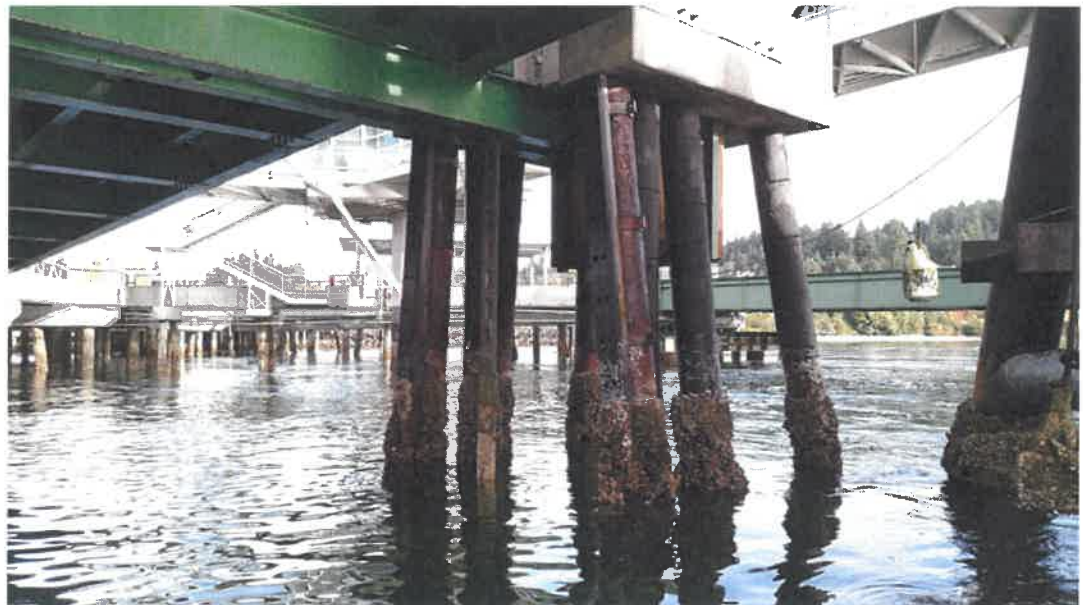
SI-77

8128 STEEL SUBMERGED PILE/COLUMN:
Protective coating on the steel tower piles is beginning to fail (Photos #77, #78, and #85).

Left tower steel piles protective coating is beginning to fail.

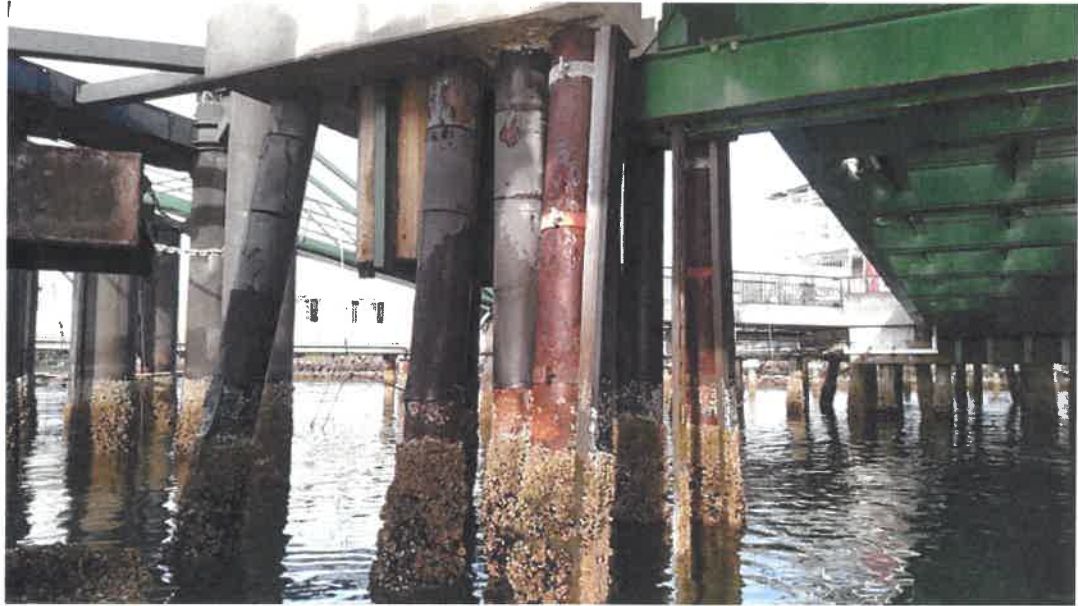
SI-85

Right tower steel piles protective coating is beginning to fail.

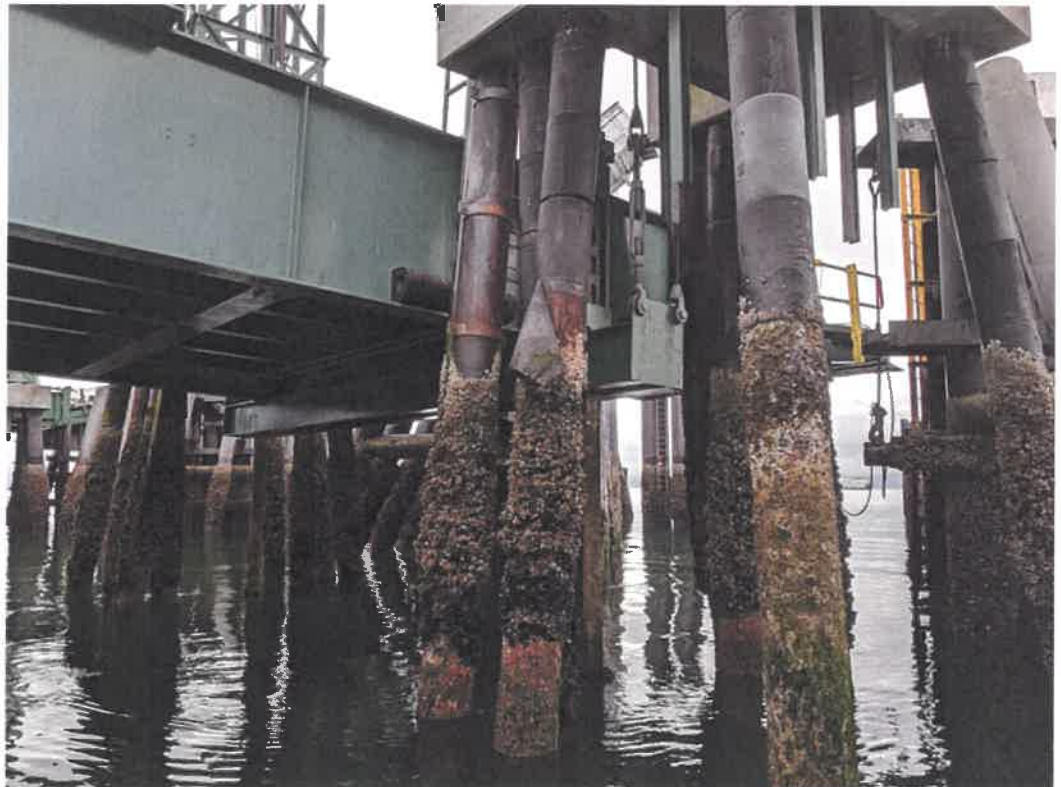
Right tower Pile 1C wrap peeling off at ITZ.

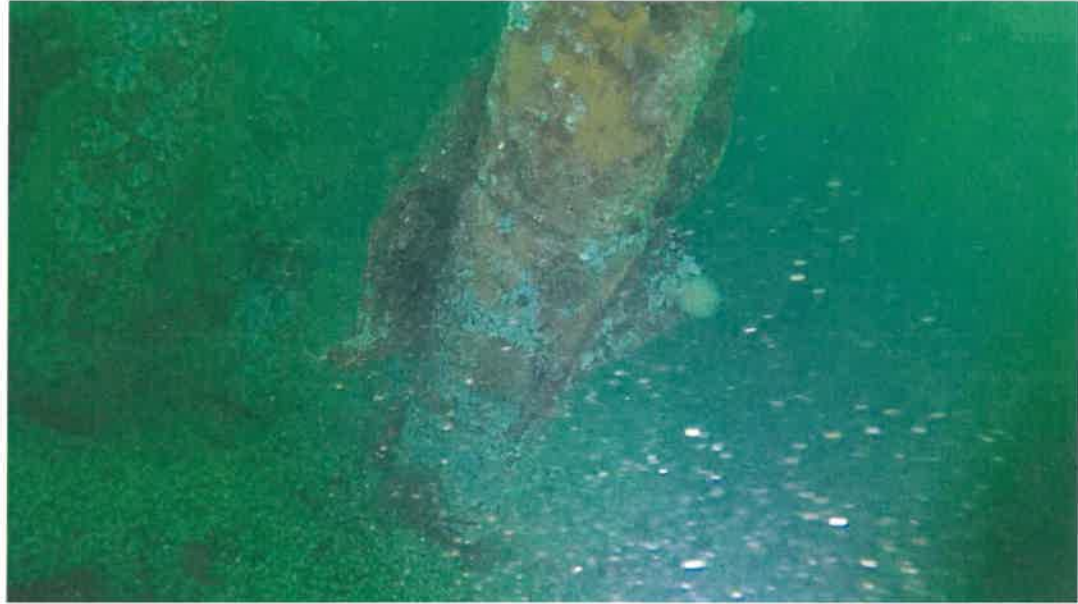
Underwater Inspection Findings:
All steel piles typically have marine growth coverage to nearly 100%. Steel tower piles typically have extensive coating failure and scattered pitting up to 3/16" deep in areas of failed protective wrapping (Photo UW-1).

All tower piles (TL and TR) typically have failed wraps hanging on piles like peeled bananas at the bottom 4-ft. See Photo UW-1. Left tower piles have up to 50% coating failure in exposed areas and right tower piles have up to 75% coating failure in exposed areas.

Typical tower pile with exposed corroded steel after wrapping failed. Tower left Pile 3D shown looking right.

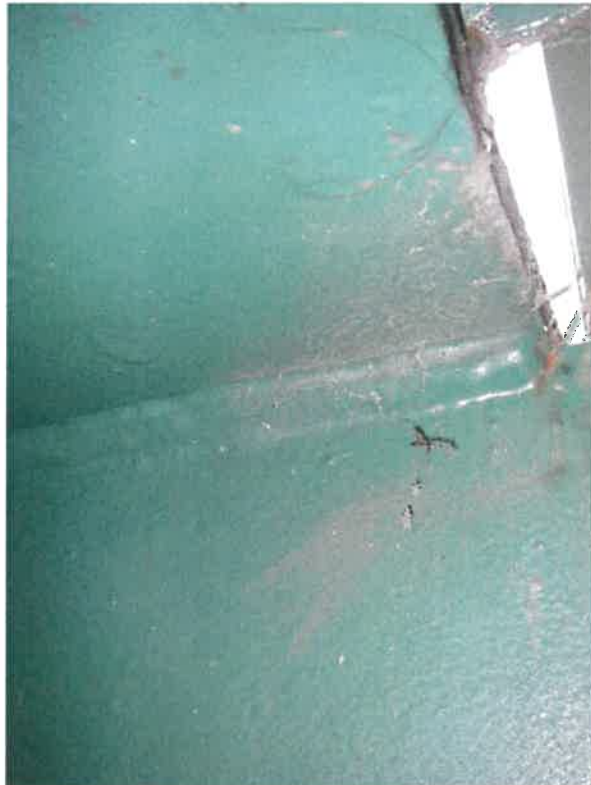
SI-67

8206 STEEL FLOORBEAM:
Floorbeam 0 left and right ends have cope cracks painted over in June 2009 which are beginning to show through the paint (Photo #67 right end). MONITOR REPAIR #10. No change in 2019.
Floorbeam 9, right and left side bottom gussets have 1/8" thick laminar rust (Photo #66). REPAIR #15.

Right (Shown) and Left cope cracks at FB 0 were painted over in 2009 and are now beginning to show the cracks again.

Repair No	Pr	R	Repair Descriptions	BMS	Noted	Maint	Verified
10	M	B	MONITOR Floorbeam 0 ends which are cracked about 1/2" at copes. No change in 2019 - CRT/MDM.	8206	9/2/2003		
15	1	B	In areas of rust blooms and laminar rust on Floorbeam 9, clean to bright steel, prime, and paint.	8206	9/15/2015		
16	2	B	Verify that the cotter pins are sufficiently secured at the following locations: Upper left live load pin, Upper middle pin at each counterweight. In 2017, these cotter pins were only marginally bent.	8343, 8419	9/20/2017		
17	1	B	Grease the lower live load pins to limit rust formation.	8343	9/10/2019

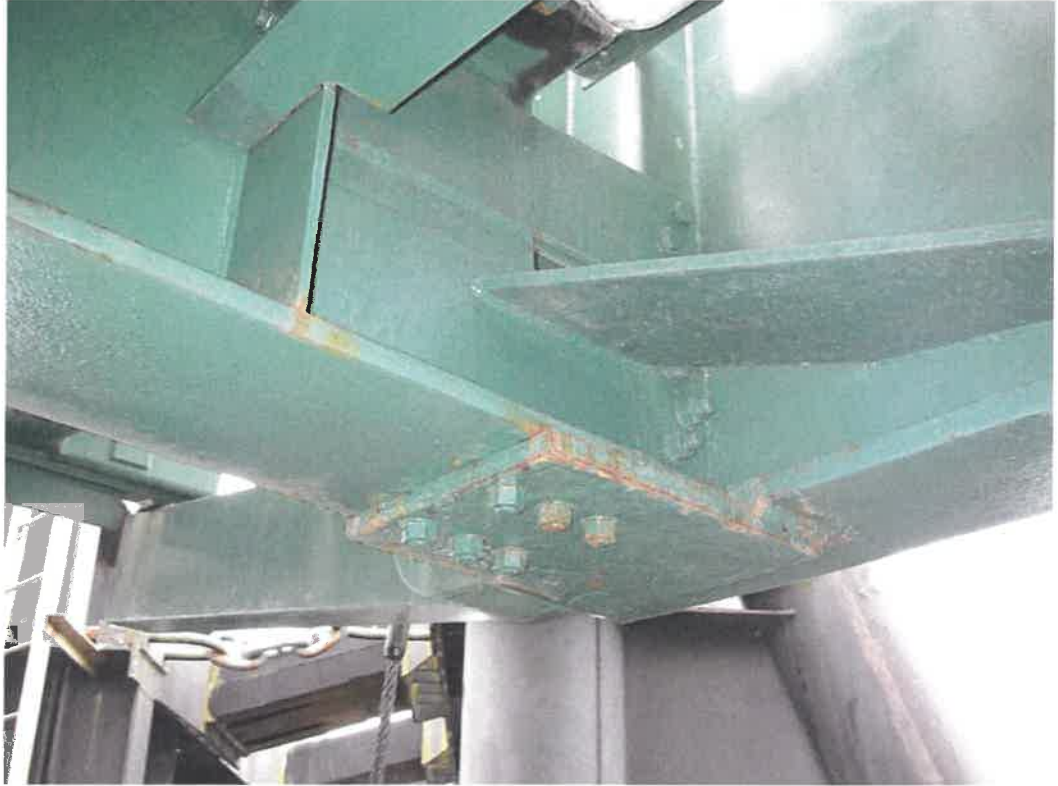
Floorbeam 9, right and left side bottom gussets have 1/8" thick laminar rust, right side shown.

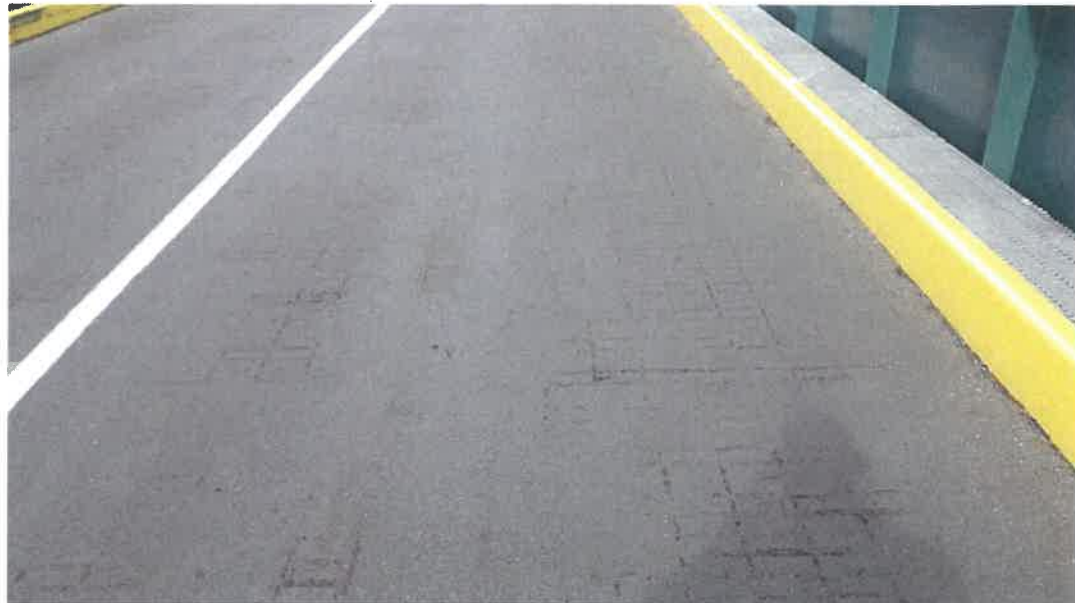
SI-74

Transfer span overlay has grid deck shadow from rust lifting overlay 1/8" with no spalling yet.

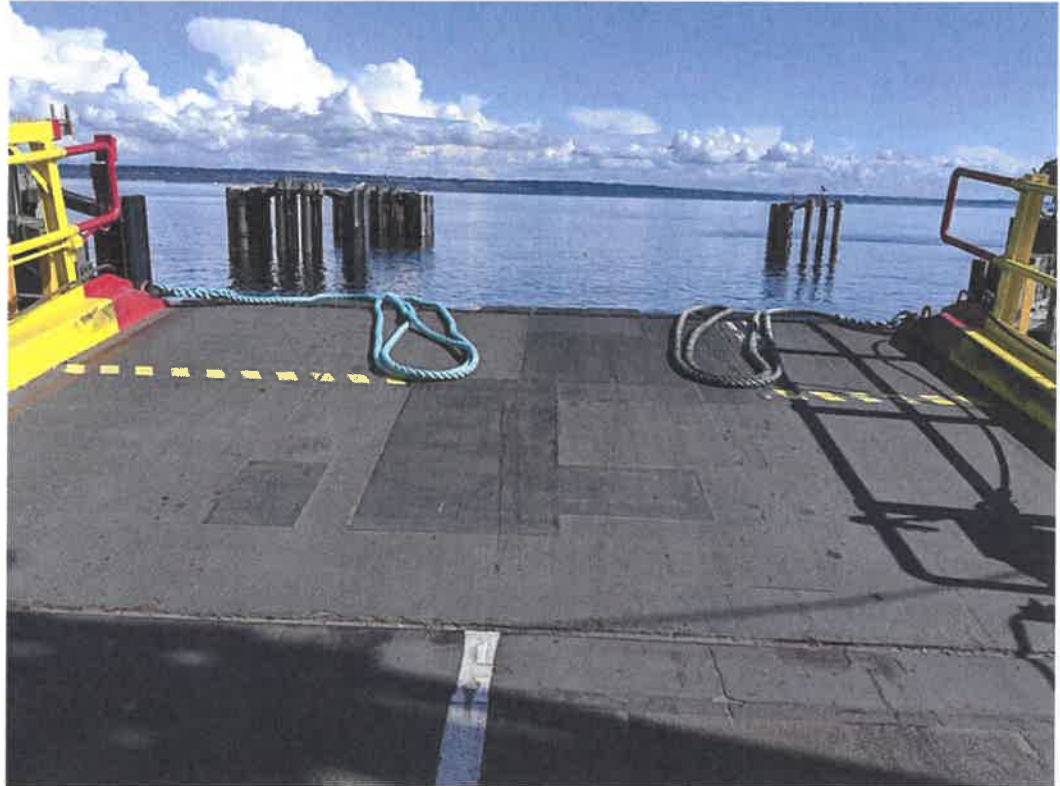
Apron surfacing has scratches and patches.

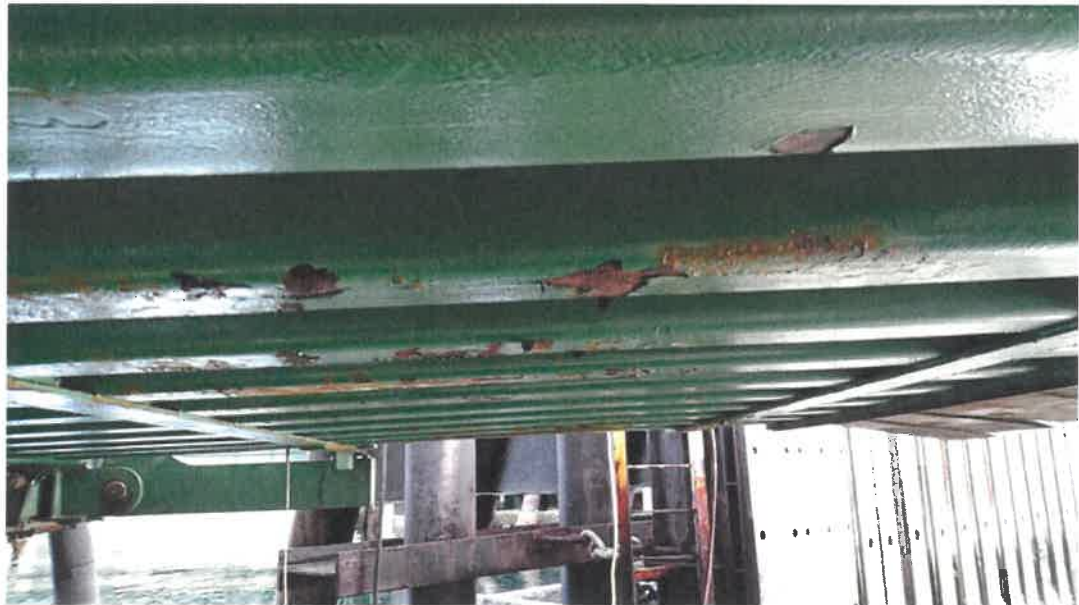
SI-79

Scattered paint scrapes and surface rust on bottom of apron.

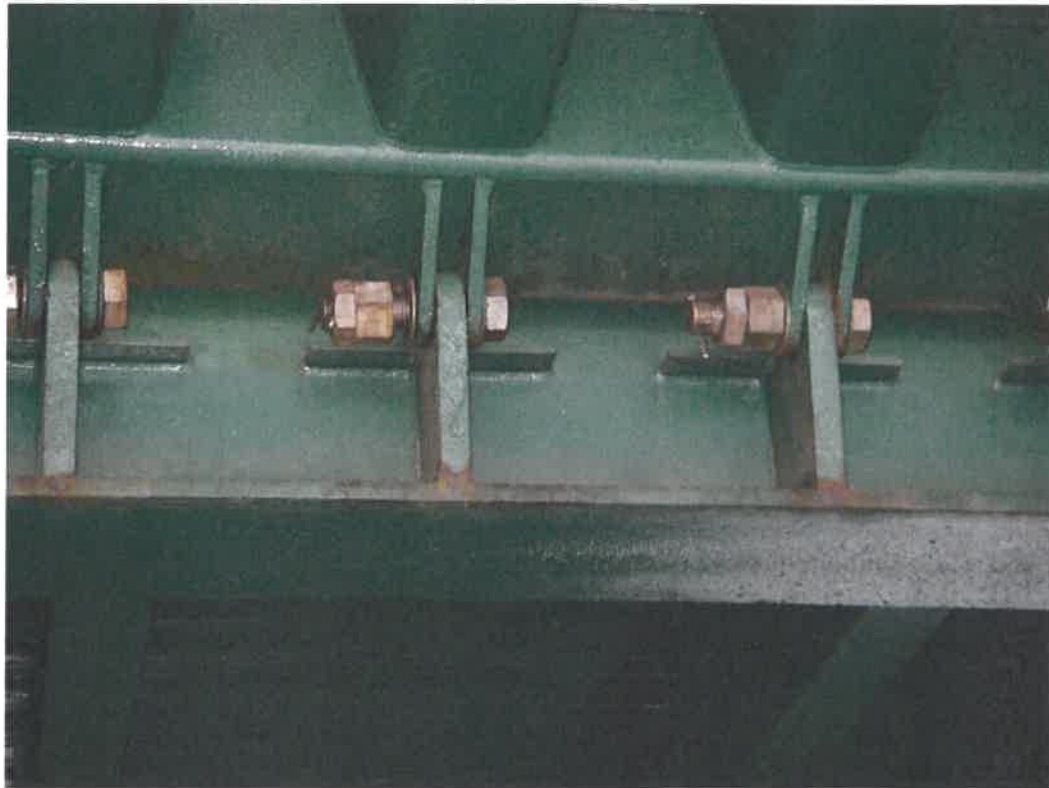
Some of the apron hinge nuts are not snug, but cotter pin is holding in place.

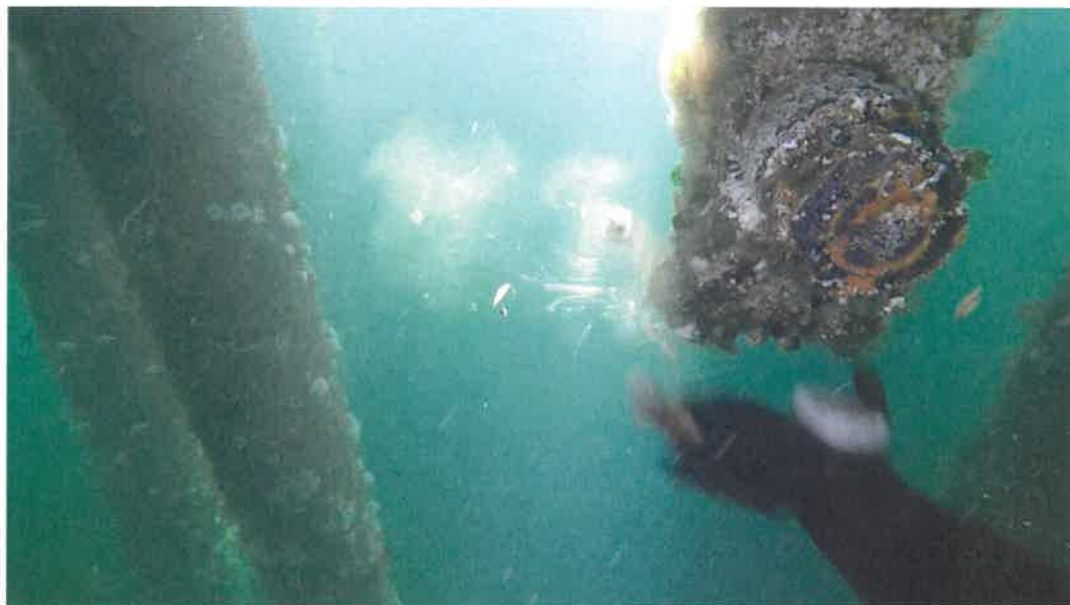
UW-2

Both live load hanger stops are round steel cylindrical stops and are intact. Right live load hanger shown looking right.

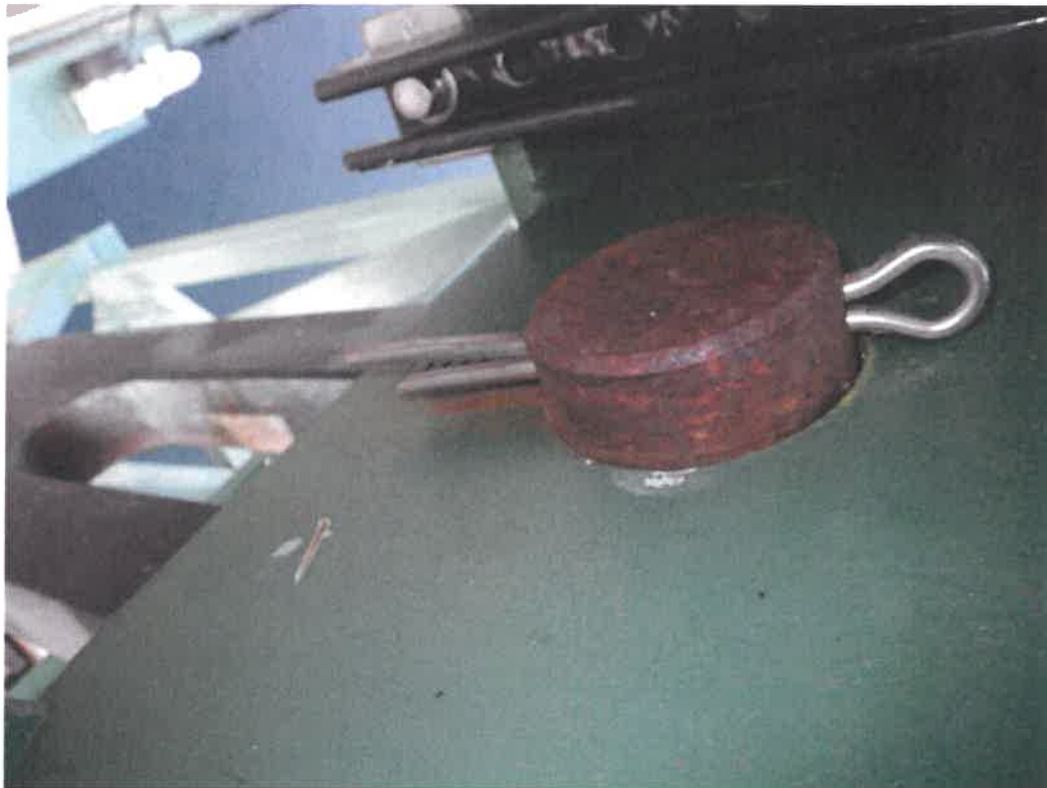
Upper left live load pin showing
marginally bent cotter pin.

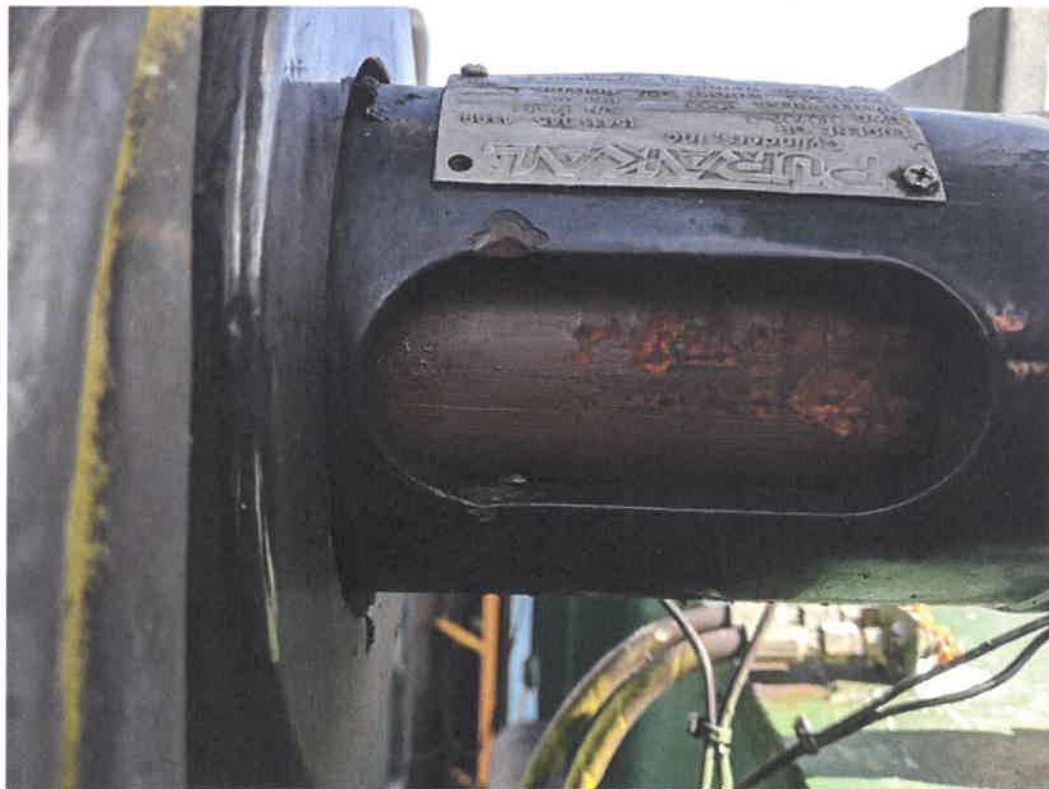
SI-86

Lower left live load pin has surface rust.

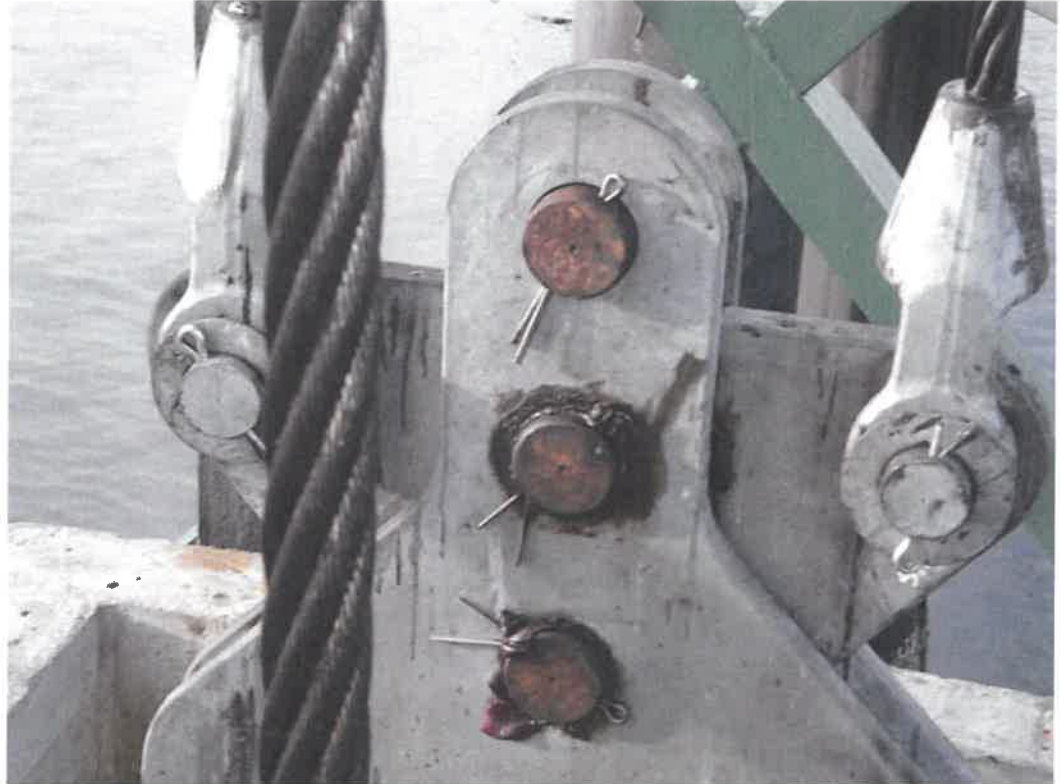
See attached underwater layout for locations and details.
- 8390 FIXED BEARING:
Bearings are covered in dirt and are rusty where exposed.
Left bearing has no clearance when transfer span is moved up and down. The ends of anchor bolts jam against the upper rocker plate and have worn 1/8" (take photo during next inspection).
- 8408 STEEL SLIDING PLATE:
Bridge seat sliding plate above compression seal.
- 8413 STEEL TOWER:
Grout pads have leaching cracks.
- 8417 TOWER BASE PLATFORM:
Leaching cracks in tower pedestals and caps.
- 8418 COUNTERWEIGHT GUIDES:
Guides on right tower have some surface rust.
- 8419 CONCRETE COUNTERWEIGHTS:
Upper pin on each counterweight has a cotter pin which is not fully bent (Photo #83). REPAIR #16.

Counterweight cotter pin not fully bent.

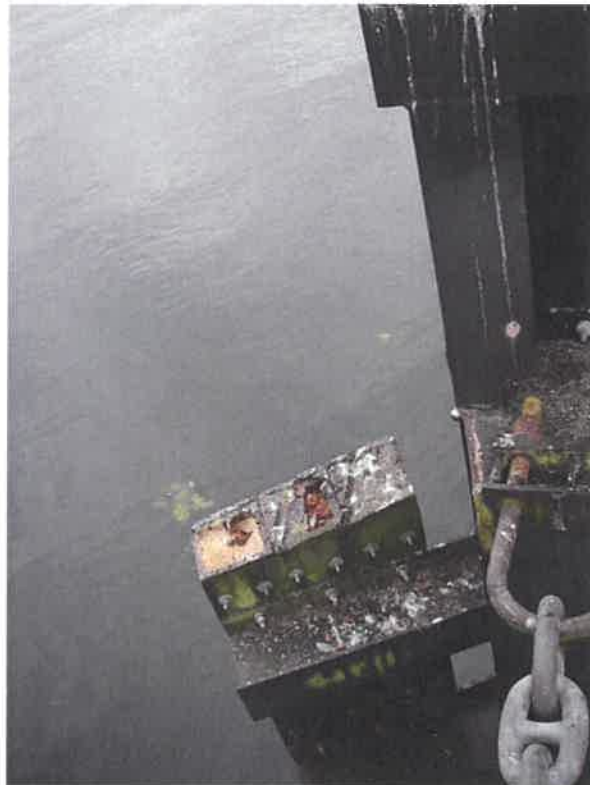
SI-71

The outer rubbing timber on the left wingwall is rotten with a 1" shell on top (Photo #71).
Seven plumb and five batter steel piles per wingwall. Piles showing laminar rust at high water line (Photos #72 and #73.)
Rubbing timbers are rotten from high tide line down for all but two timbers of the left wingwall and about half of timbers for the right wingwall. Replacement is planned for 11/2019. (Photo #84).

Left wing wall, left end rub timbers are rotting at the top.

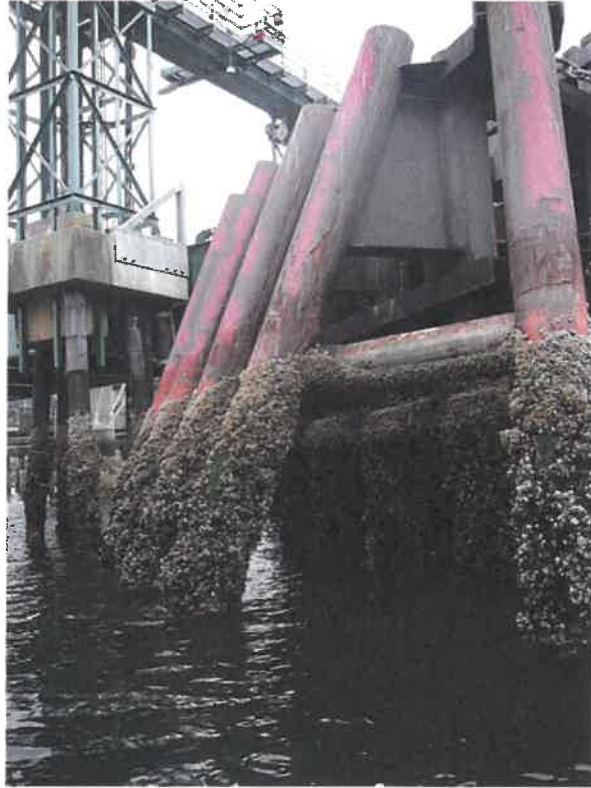
Left side wingwall piles showing laminar rust at high water line.

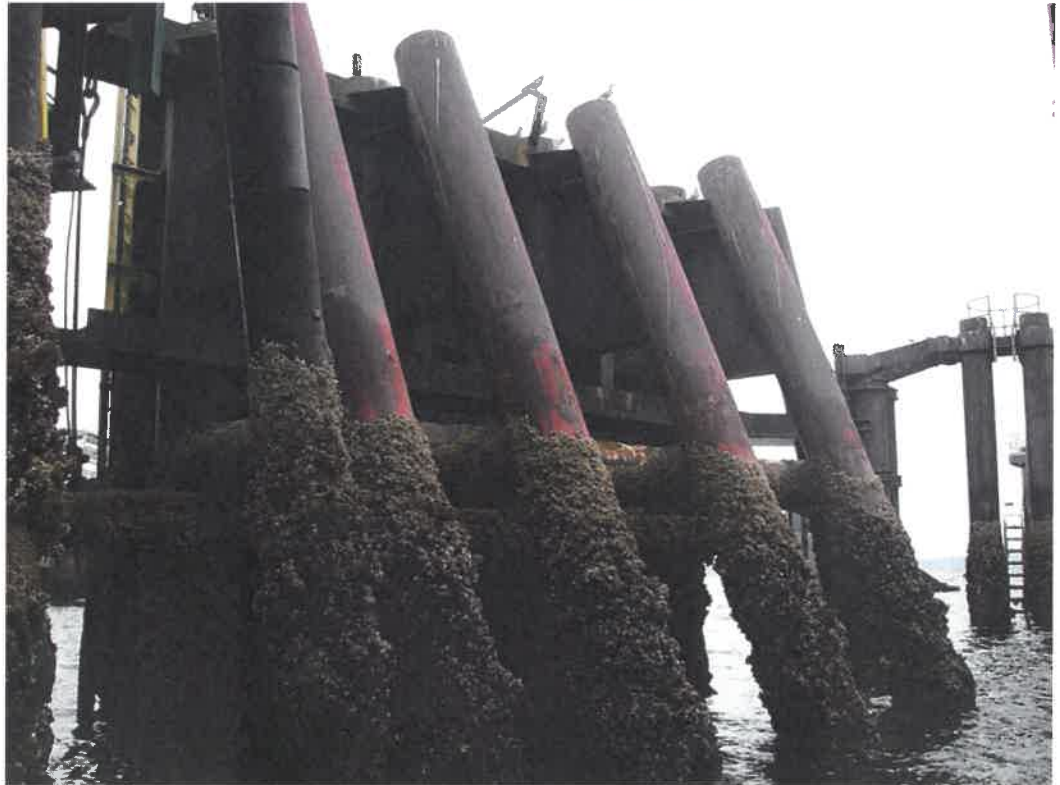
SI-73

Right side wingwall piles showing laminar rust at high water line.

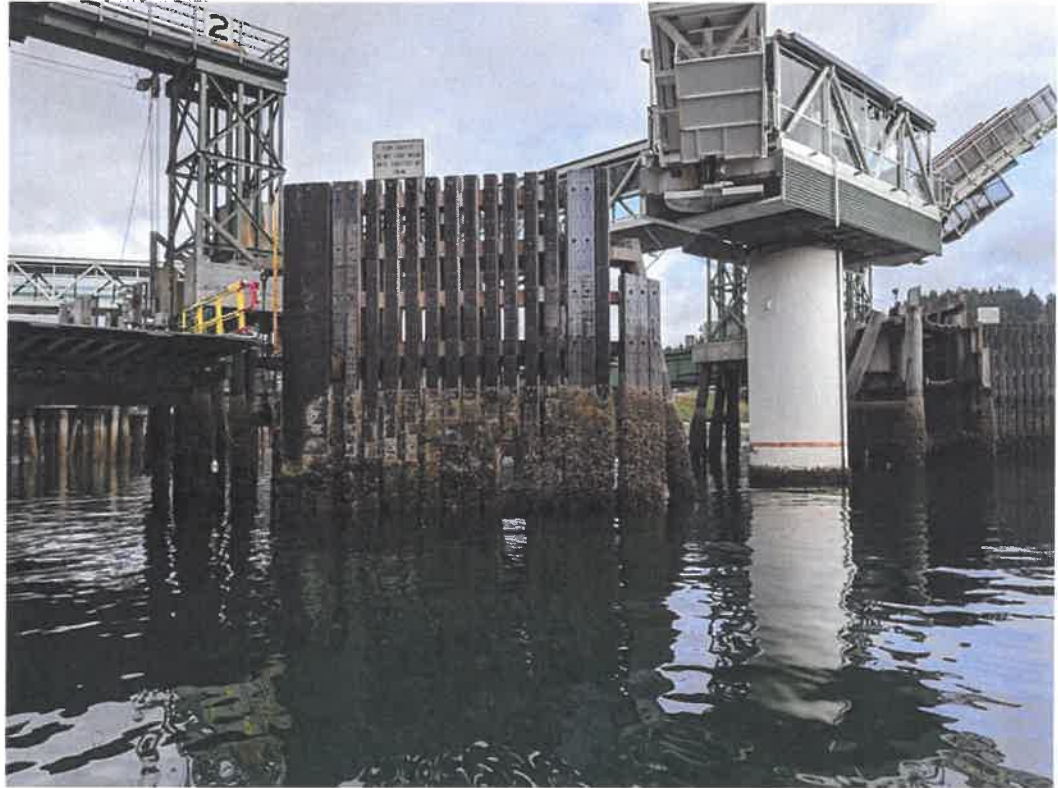
Left wingwall missing bottom end of several rubber timbers, with mulitple showing rot in bolt holes. Right wingwall is similar.

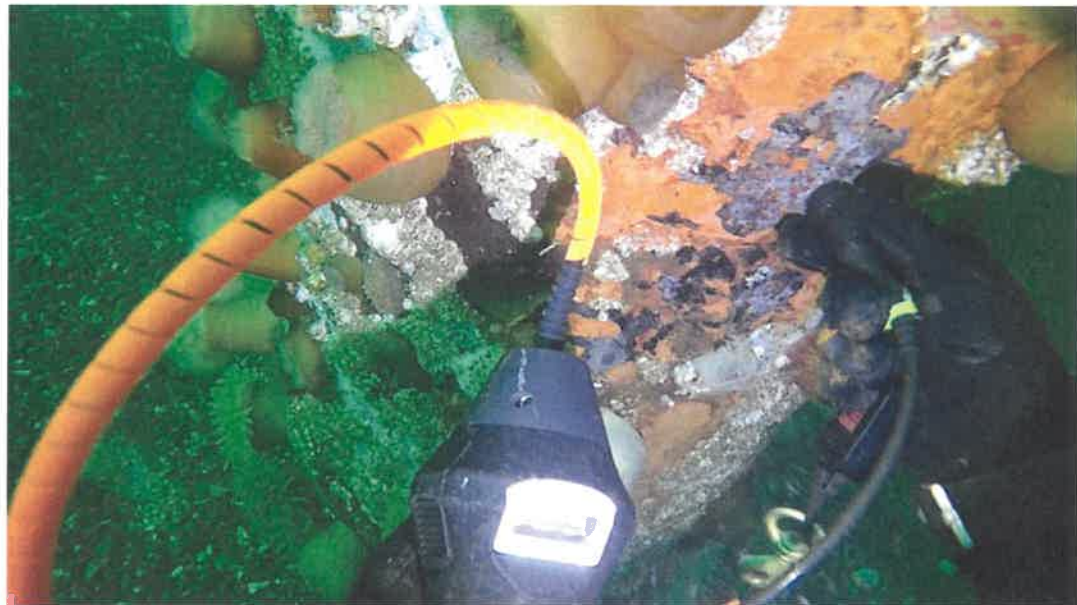
UW-3

Right wingwall piles have small areas with up to 50% section loss. Thickness reading taken on Pile 2B shown.

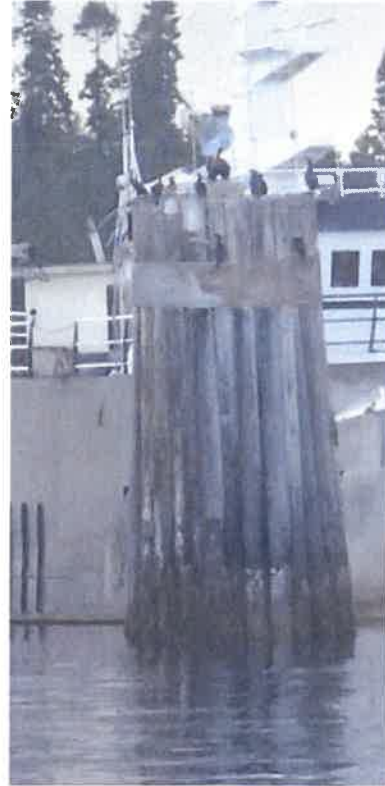
Tie-up Slip 3 inner right timber dolphin rubbing faces are missing (Photo UW-4). Two timber piles are crushed and splintered at the surface (UW-5). There were two sets of steel cable wraps below water, the lower wraps were intact and the upper wraps were not.

Tie-up Slip 3 inner right timber dolphin rubbing faces are missing.

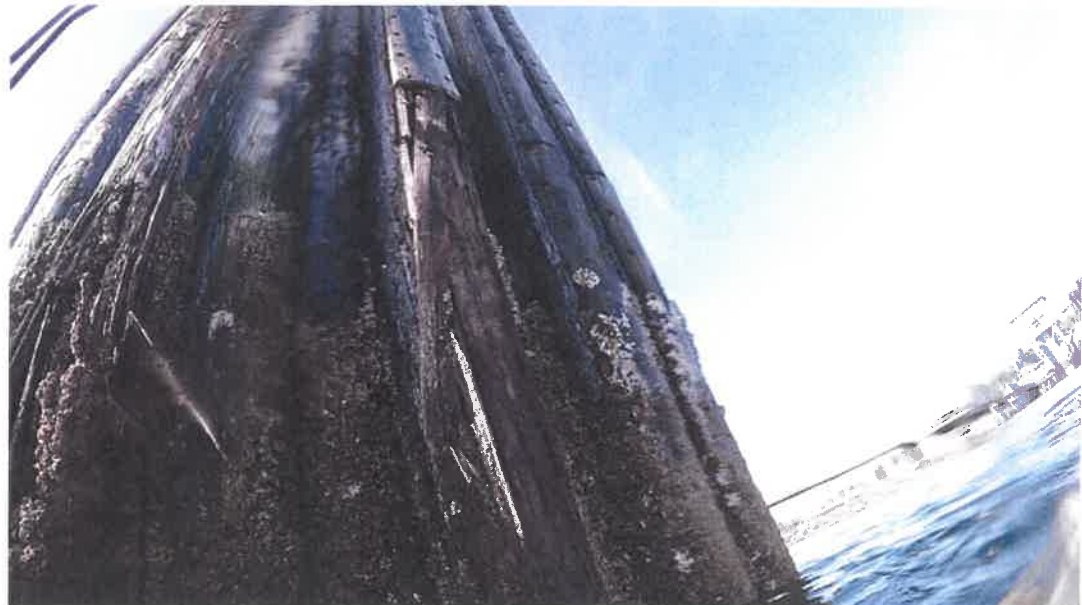
UW-5

Two timber piles are crushed and splintered at the slip side surface.

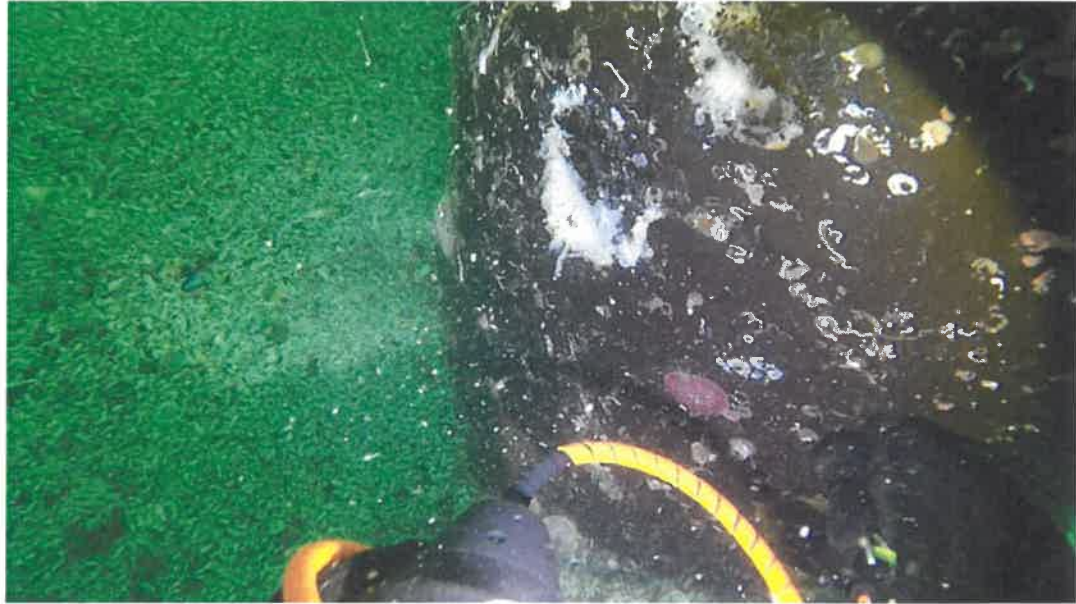
Level II cleanings and random thickness readings were taken of the steel near mudline. RO Pile 2C shown looking offshore.

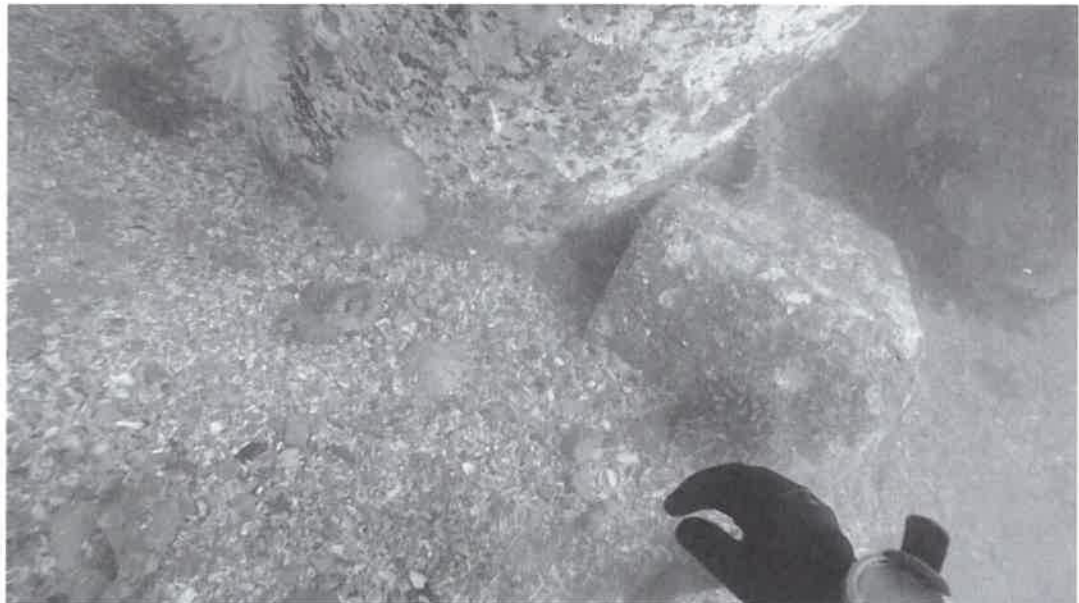
UW-7

Slip 2 Left Inner (LI) ladder sinker block is resting against Pile C1 slip side. Color reduced for visual clarity.

Recommend re-attaching sinker blocks to ladders on Slip 2 inner left, Tie-up Slip 3 outer left and outer right dolphins. Maintain a 60-month underwater inspection frequency.

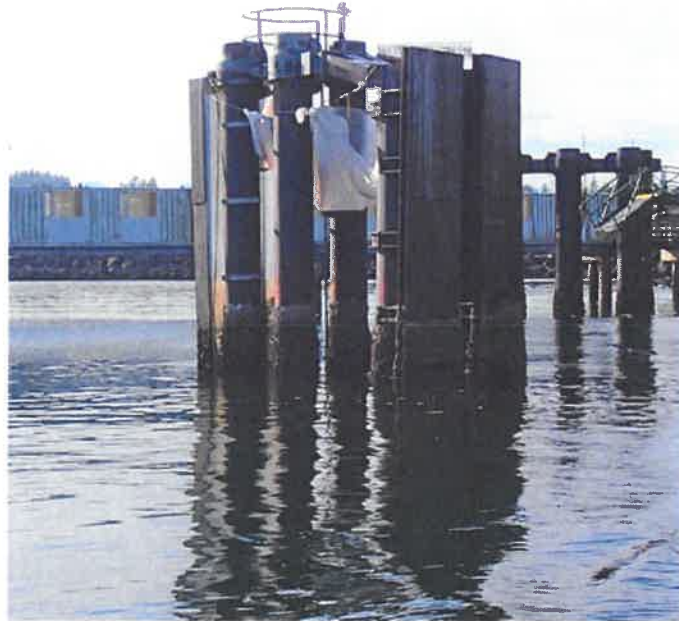
Slip 2 Right Inner (RI) is a 6 steel pile frame dolphin and has new extruded fenders on the Tie-up Slip 3 side Piles C1 and C2.

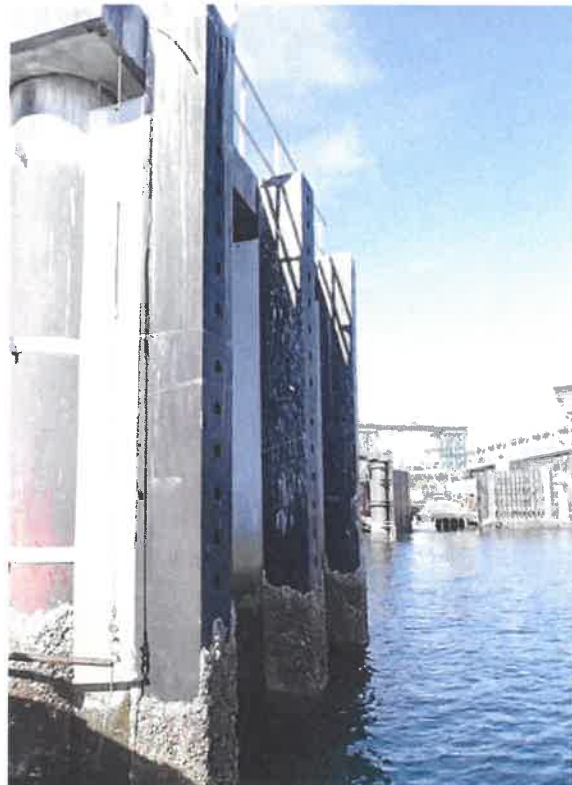
UW-9

Tie-up Slip 3 Left Outer (TLO) is an 11 steel pile frame dolphin. It has new extruded fenders attached to the Slip 2 side Piles D1, D2, and D3 (Photo UW-9). Up to 10% coating failure with some pitting is typical bottom 10-ft. Pile 3B has 2 sq. ft. area of coating failure with up to 25% section loss (Photo UW-10). Pile A2 has 1.5 sq. ft. area of section loss with 3/4" diam. pit up to 1/4" deep (Photo UW-11) all within a 1-ft full circumference band of coating failure.

Tie-up Slip 3 Left Outer (TLO) dolphin has new extruded fenders attached to the Slip 2 side Piles D1, D2, and D3.

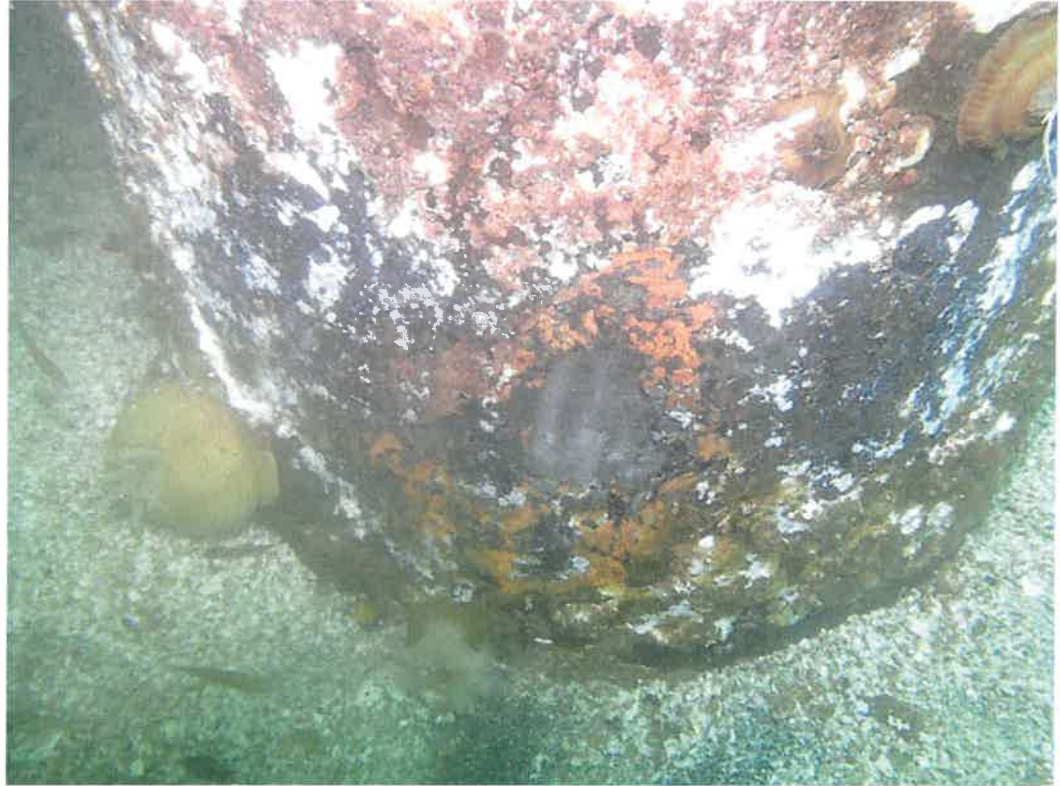
TLO Pile 3B has 2 sq. ft. area of coating failure with up to 25% section loss.

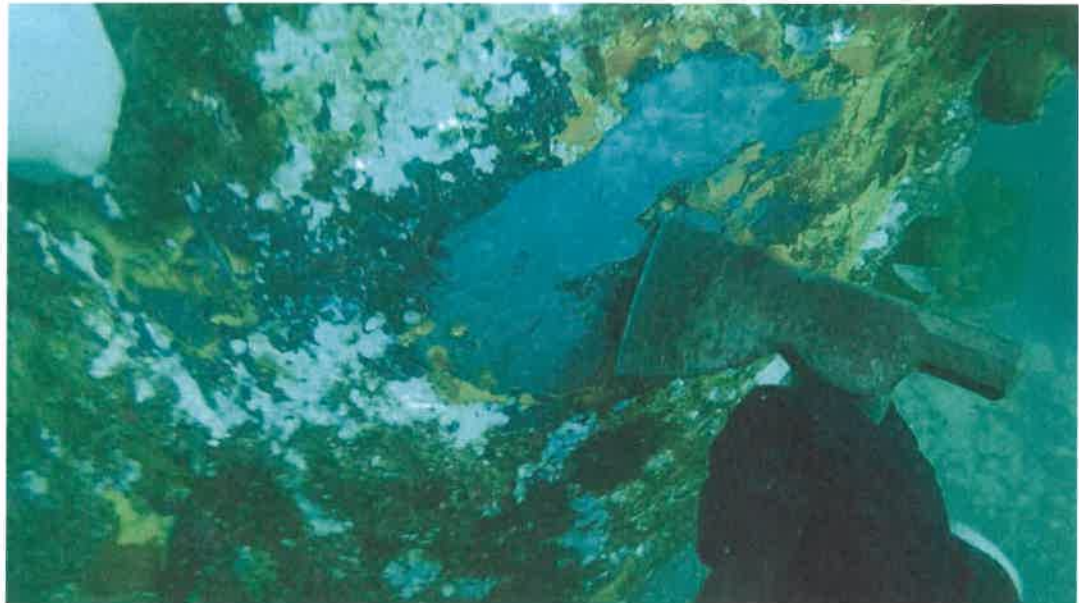
UW-11

TLO Pile A2 has 1.5 sq. ft. area of section loss with 3/4" diam. pit up to 1/4" deep all within a 1-ft full circumference band of coating failure.

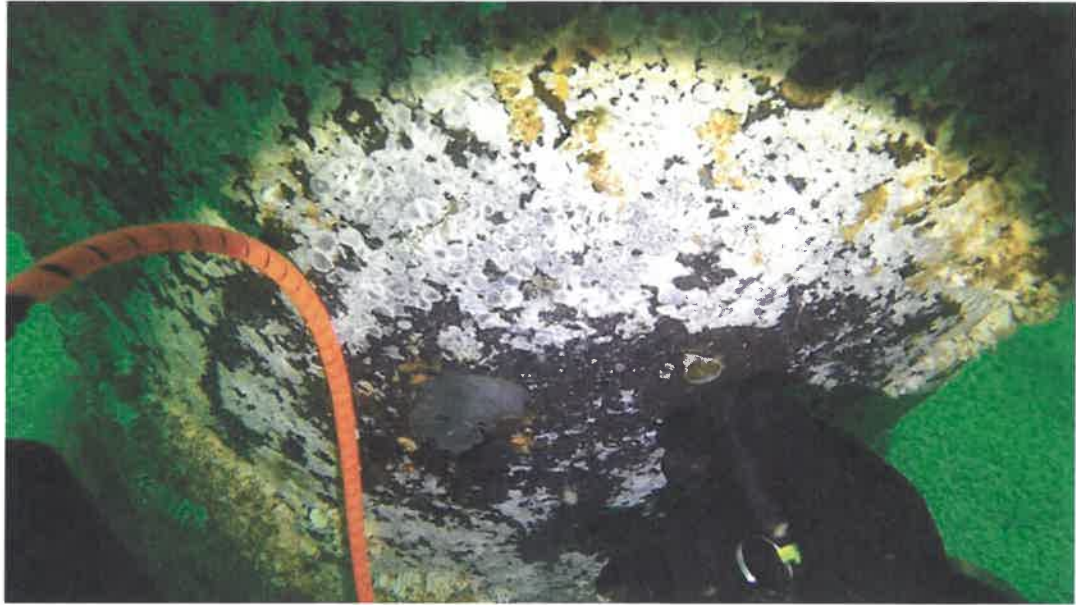
TRO piles typically have small areas of pitting up to 1/4" deep at the bottom 2-ft.

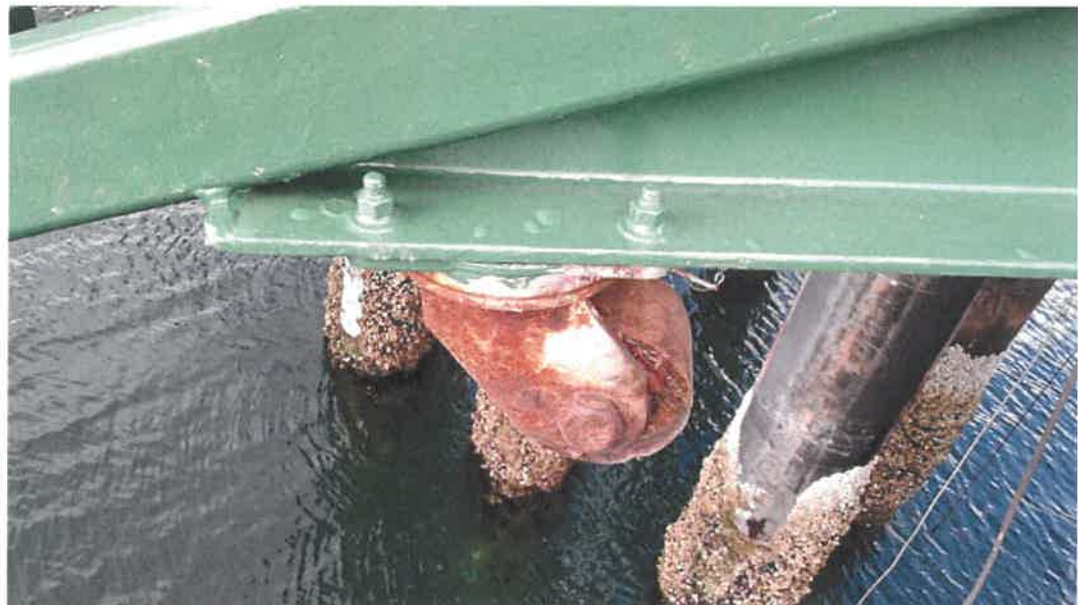
The apron has four casters attached to its underside. These casters rest on the ferry deck when the support hoist lowers the gangplank to the ferry deck. Castors are covered with surface rust (Photo #81).

Rusty castor in Tie Up Slip #3
Gangplank.

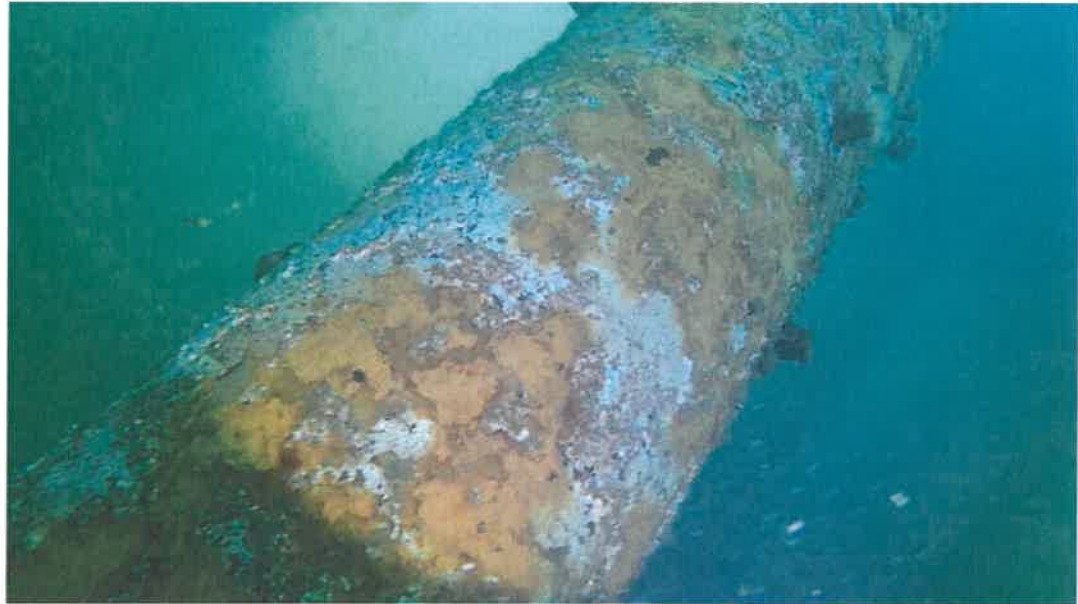
LW piles have up to 20% coating failure of the bottom 10-ft (Photo UW-13). The backside of Row 3 batter piles appears to be sandblasted from the Aux. Slip 1. A large mound of sand and sea shells are behind these batter piles.

Slip 2 Left Wingwall (LW) piles have up to 20% coating failure at the bottom 10-ft. LW Pile 3D is shown with 20% coating failure on its backside from 4o'clock to 8o'clock.

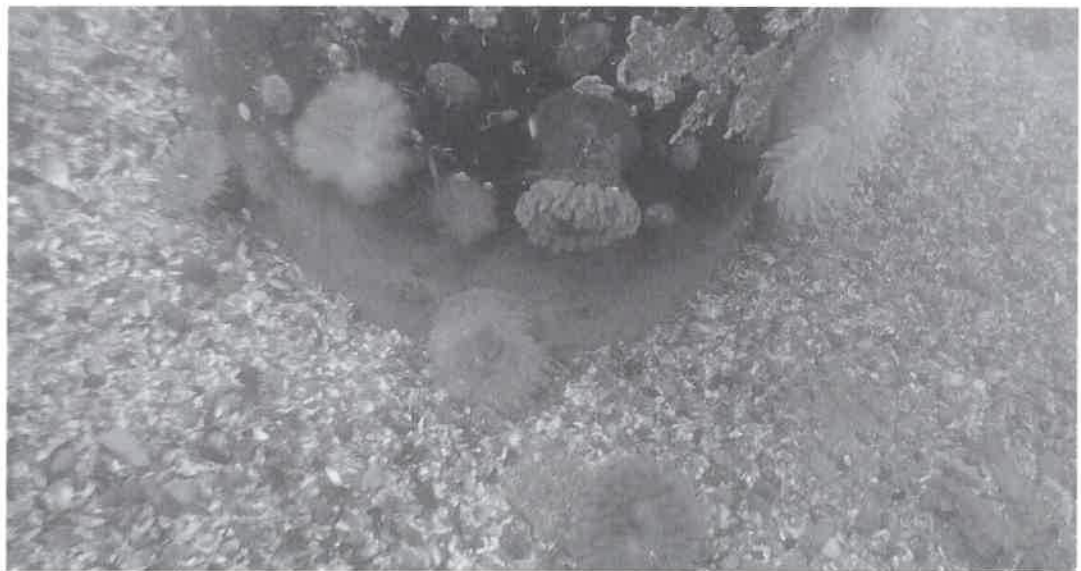
UW-14

All Slip 2 Right Inner Dolphin (RI) piles have a typical 6" band of paint discoloration with some paint bubbles. RI Pile 2B shown looking offshore. Color reduced for clarity.
